AlphaStation XP900

Release Notes

EK-DS10V-RN. A01

August 1999

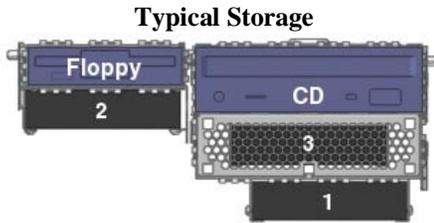
Systems without the TLZ10 tape drive typically ship with the CD-ROM in the position shown. If you install a TLZ10 tape drive into an installed AlphaStation XP900, the CD-ROM must be moved to storage bay 3. Then the TLZ10 tape drive is installed into the upper right storage bay, where the CD-ROM usually resides.
